**RE: QUARTERLY PROGRESS REPORT FOR THE AVTEX FIBERS SUPERFUND SITE FOR THE PERIOD  
APRIL 1 THROUGH JUNE 30, 2019**

# Quarterly Inspection Report

**Quarterly Inspection Report Photographic Log**  
**Avtex Superfund Site**  
**Front Royal, Virginia**

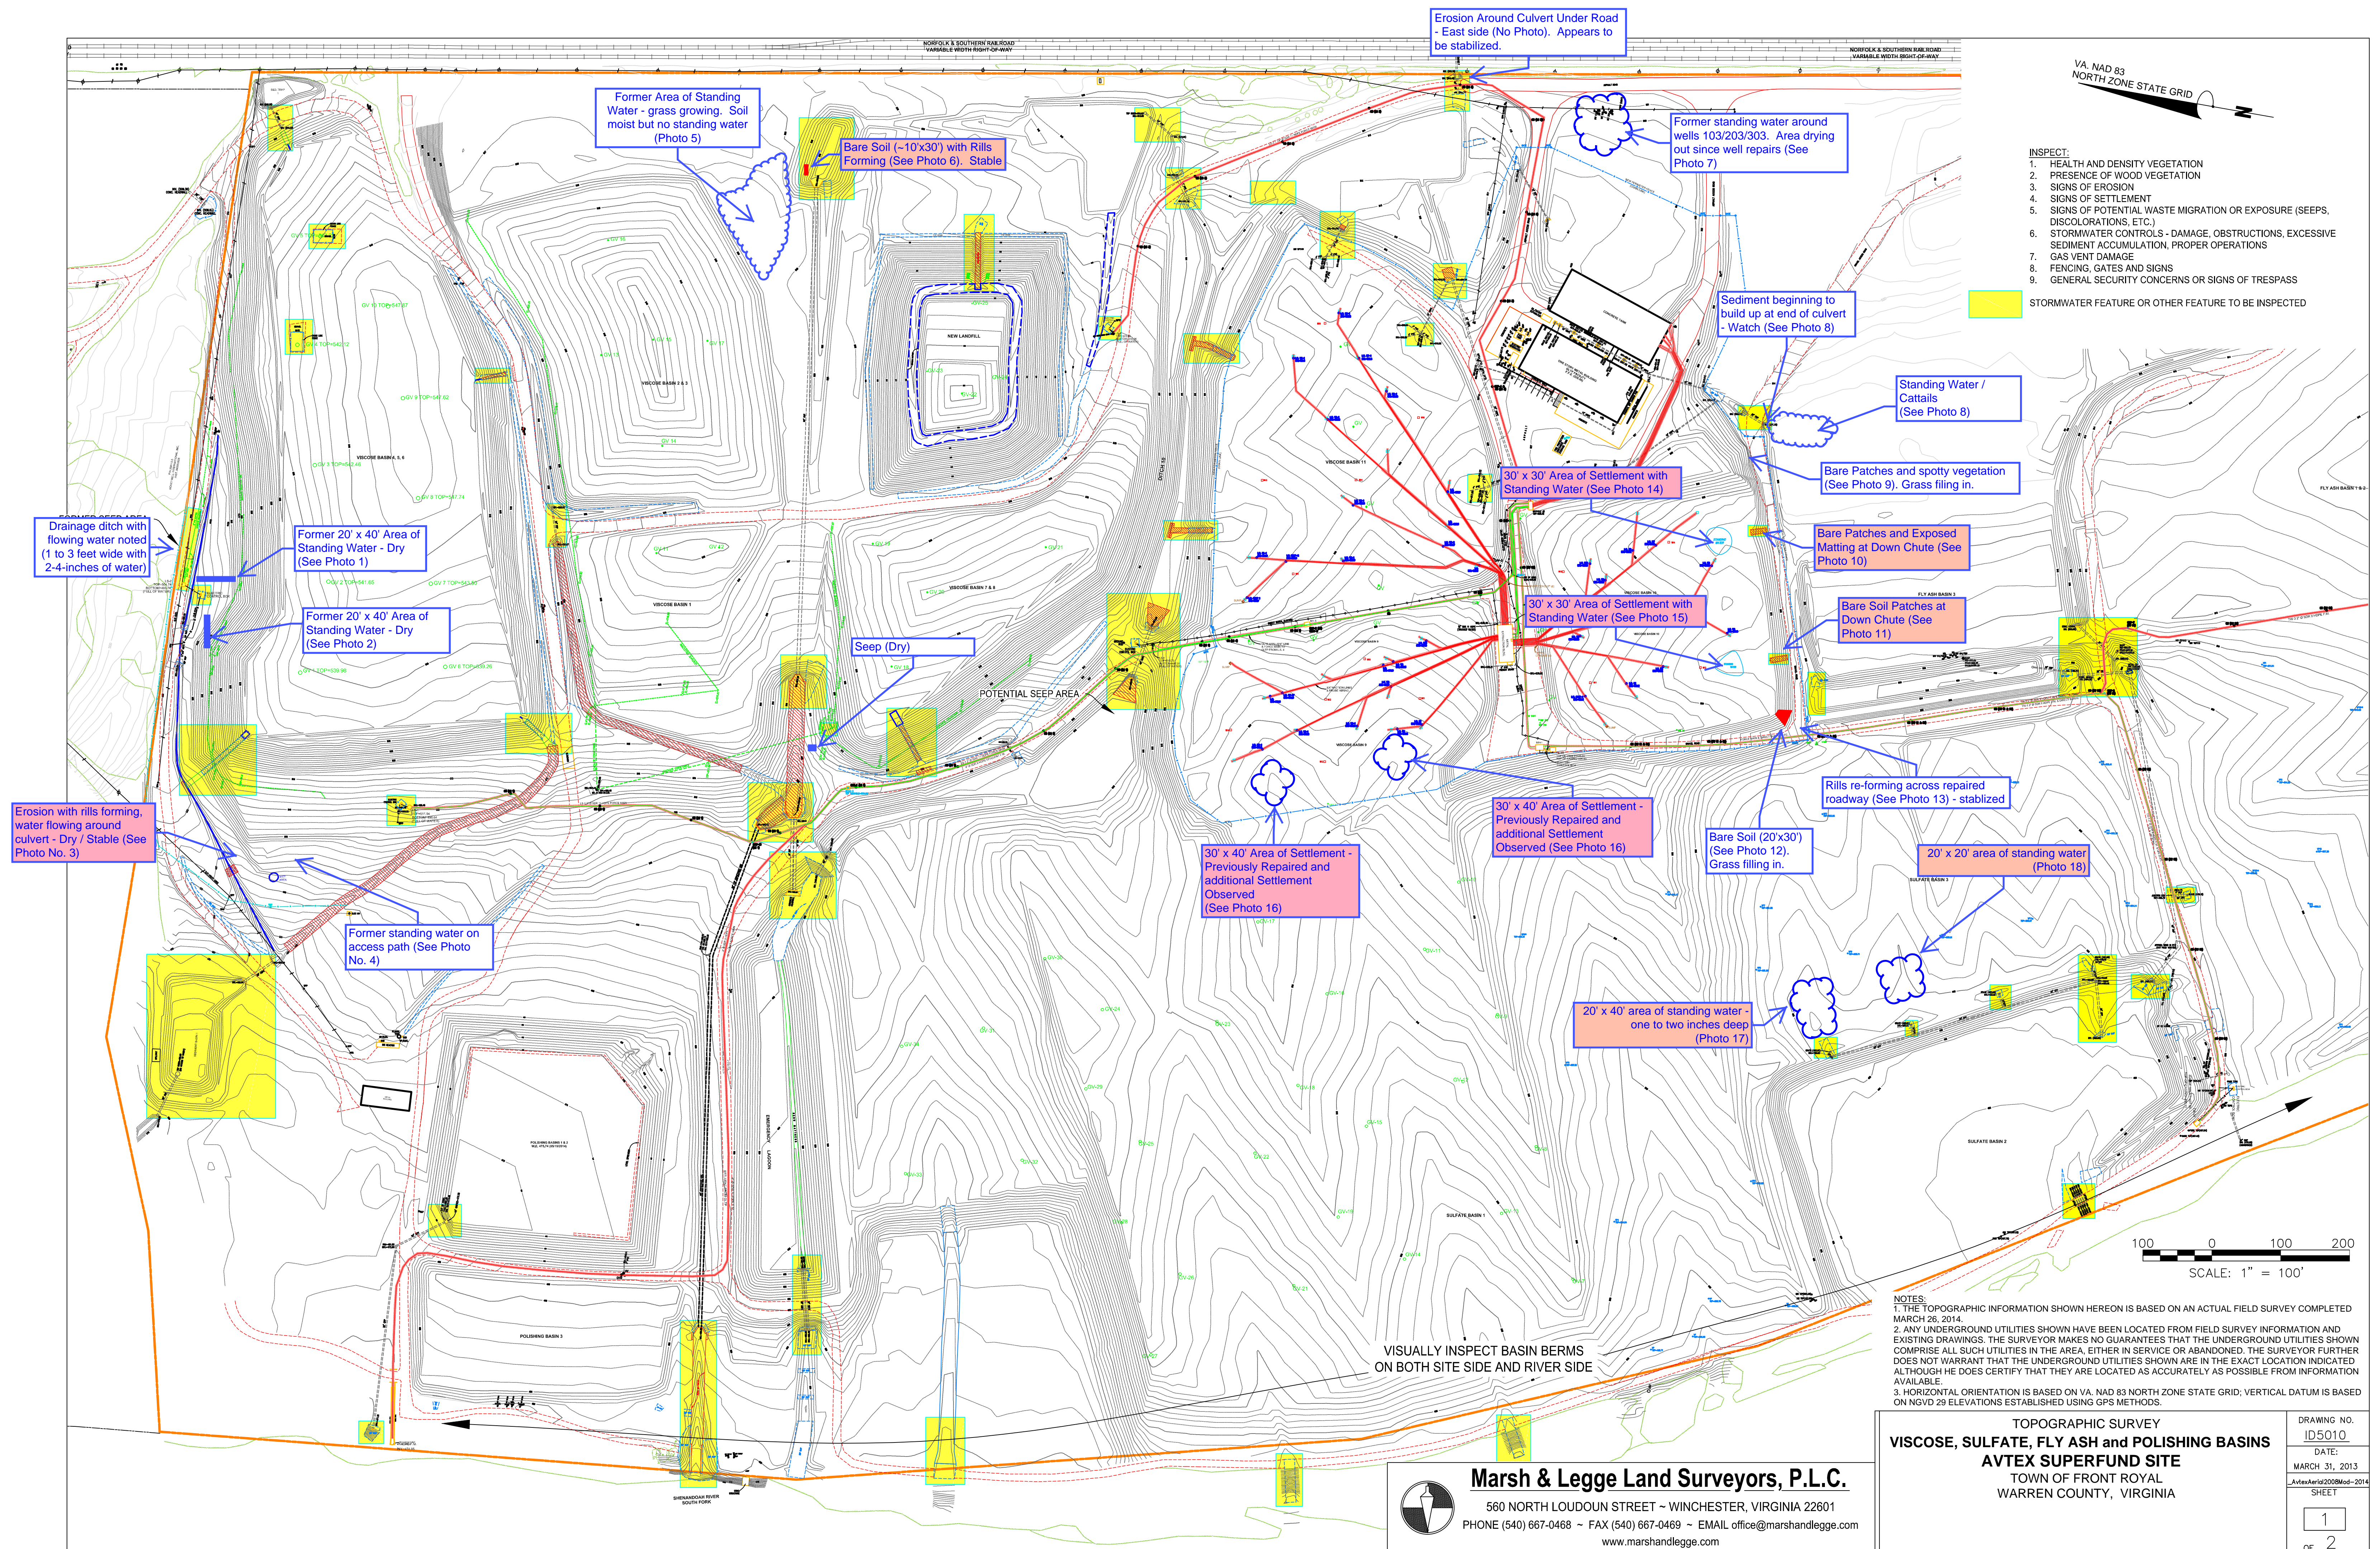
**Date :** 06/12/2019

**Photo Description:** Standing water (20'x20') in front of the second to northernmost inlet between SB-3 and SB-2.
